Prepared By:
Florida Building Inspector
10380 SW Village Center Drive, Suite 123
Port Saint Lucie, FL 34987

**Inspector: John Alcorn**

# REPORT OVERVIEW

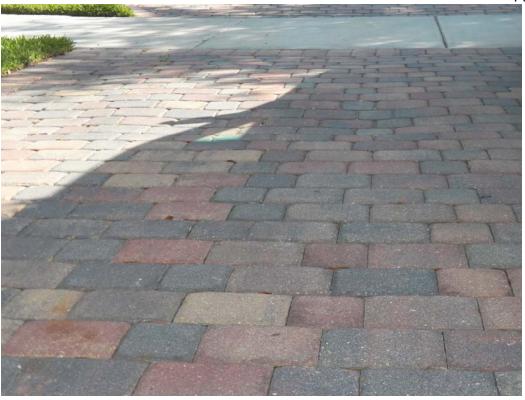
Driveway is a little wavy due to settling

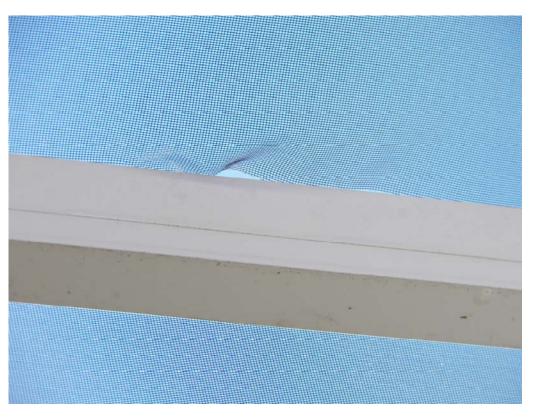
Tear in screen panel – left rear

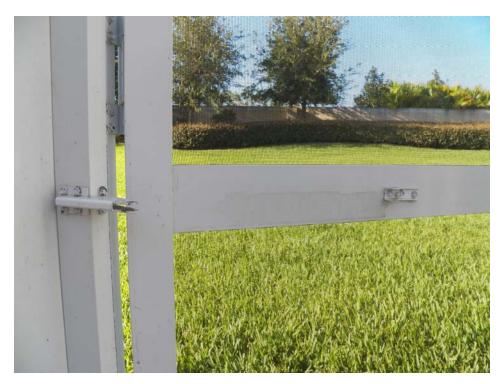
Screen door enclosure is missing – left rear door to pool area

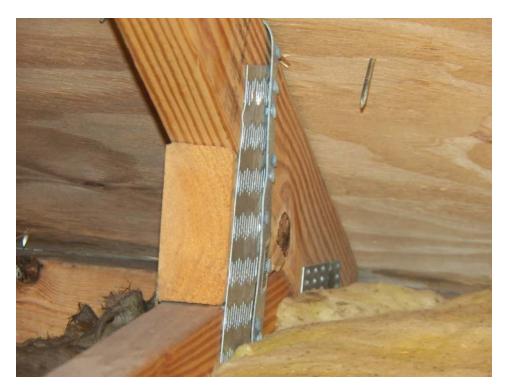
Hurricane straps properly hold trusses to wall for hurricane protection

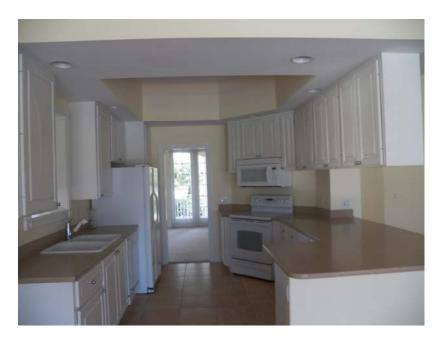
Kitchen

Corrosion on fittings under kitchen sink

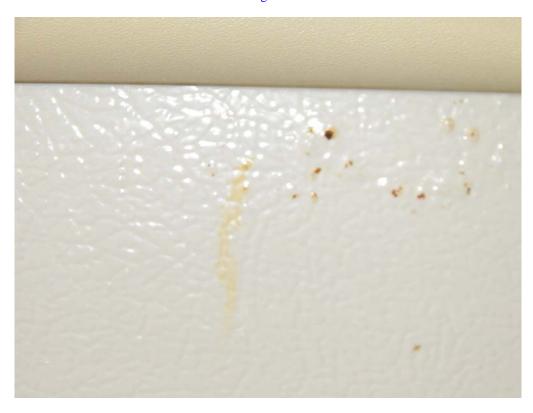
Small amount of rust on refrigerator door under water/ice dispenser

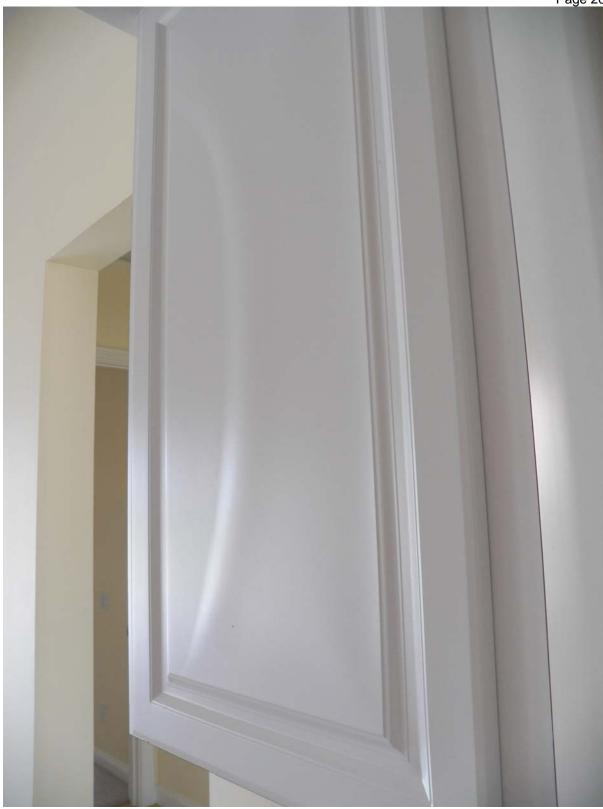
Laminate is lifting on one kitchen cabinet upper door

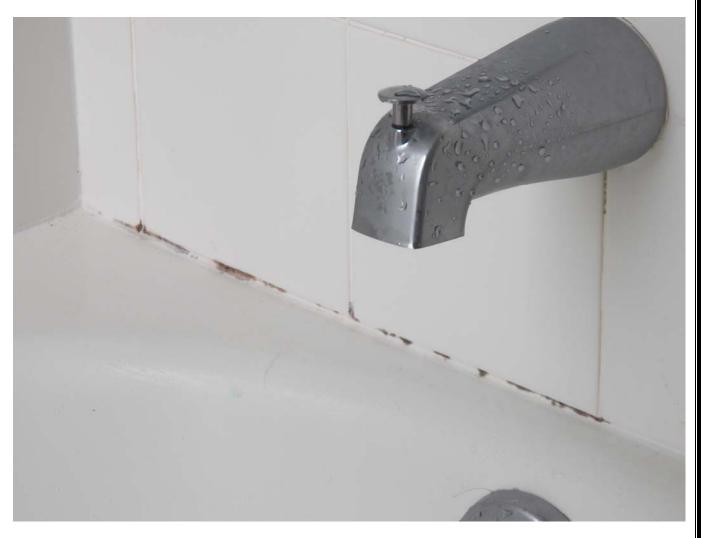
Mold at tub – both ends

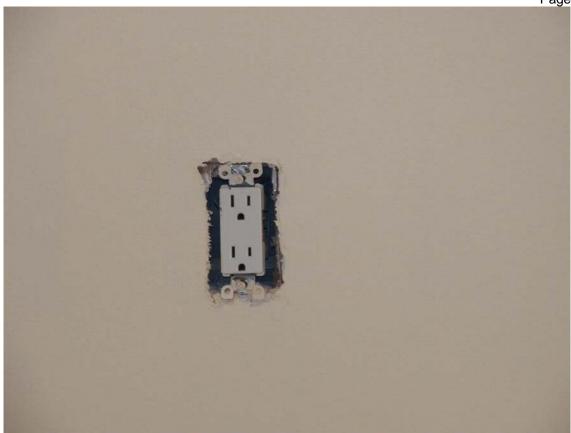
Electrical wall outlet cover is missing in left front bedroom

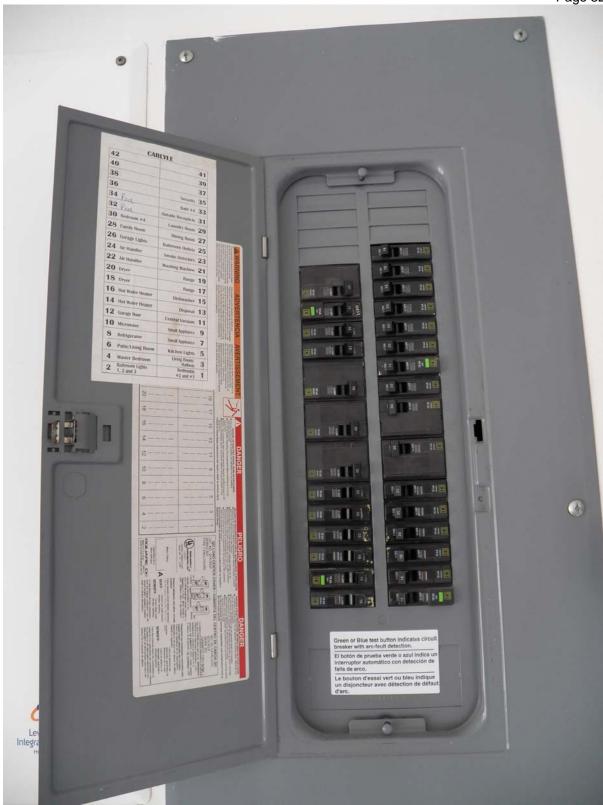
Electrical panel

(	,
Above main panel the ele	ectrical outlet's cover	ie mieeina

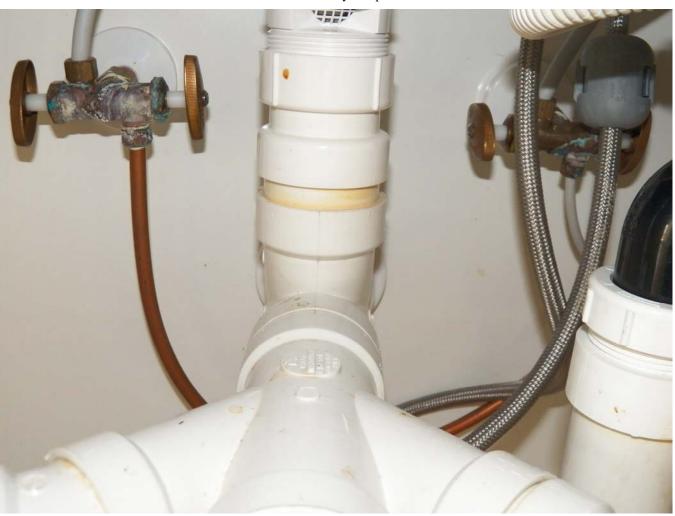
There was no evidence of a sulfur-like smell or blackening of copper plumbing lines

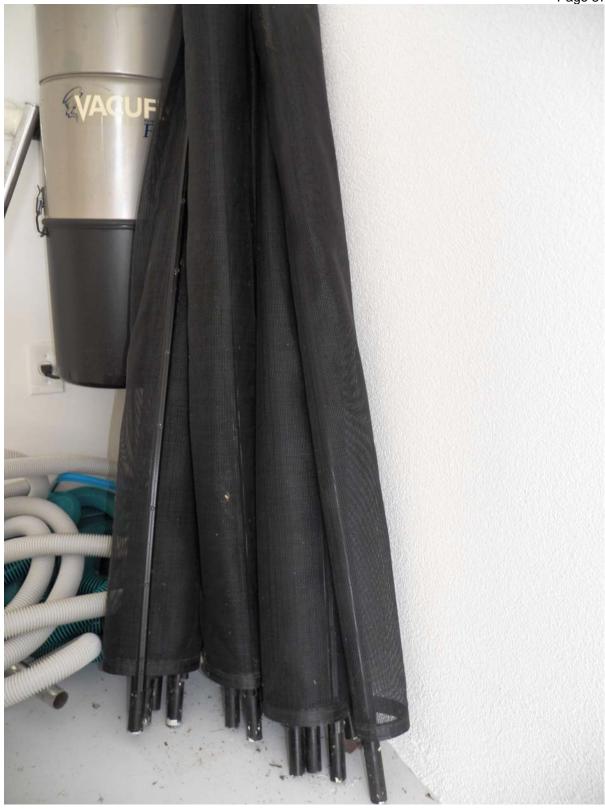
Semi-permanent mesh safety barrier(s) are stored in garage
